Bartley Ranch Regional Park and Anderson Park

A Trail Access Information

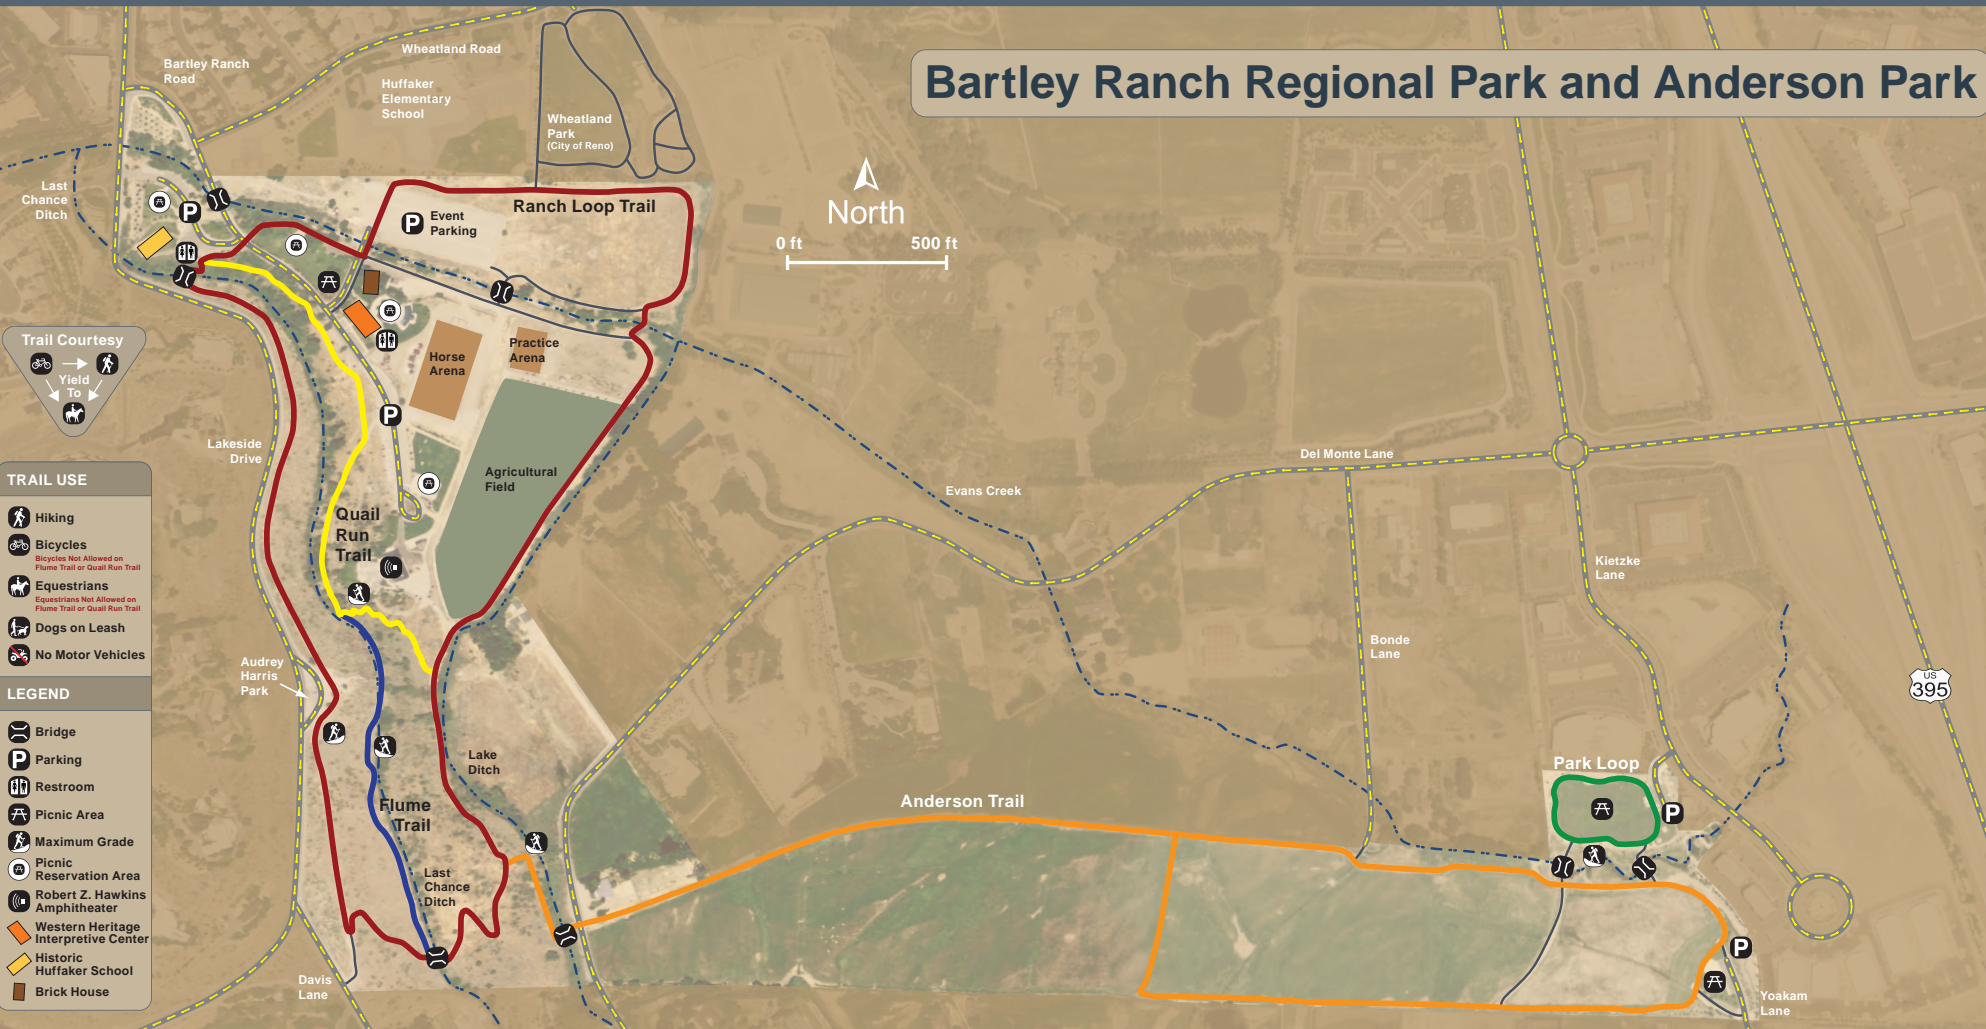
- TRAIL USE**
- Hiking
 - Bicycles
Bicycles Not Allowed on Flume Trail or Quail Run Trail
 - Equestrians
Equestrians Not Allowed on Flume Trail or Quail Run Trail
 - Dogs on Leash
 - No Motor Vehicles

Trail Name	Length	Typical Grade	Maximum Grade <small>Standard Ramp is 8.3%</small>	Typical Cross Slope	Maximum Cross Slope	Typical Trail Width	Minimum Clearance Width	Surface Type	Surface Firmness		Surface Stability	
									Typical	Worst	Typical	Worst
Ranch Loop Trail	1.5 mi	4.5%	371 ft is 16% – 25%	2.8%	18 ft is 16% – 20%	90 in	40 in	Aggregate/Gravel	0.19	0.22	0.36	0.60
Quail Run Trail	0.4 mi	7.3%	186 ft is 20% – 40%	3.5%	46 ft is 18% – 30%	60 in	25 in	Aggregate/Gravel	0.19	0.22	0.39	0.50
Flume Trail	0.2 mi	4.6%	37 ft is 14% – 19%	3.9%	47 ft is 12% – 14%	48 in	20 in	Soil	0.23	0.25	0.38	0.49
Anderson Trail (Round Trip)	1.7 mi	2.5%	196 ft is 14% – 21%	2.4%	311 ft is 7% – 11%	76 in	48 in	Aggregate/Gravel	0.19	0.22	0.39	0.52
Park Loop	0.2 mi	1.6%	64 ft is 4% – 5%	1.8%	230 ft is 3% – 4%	84 in	84 in	Aggregate/Gravel	0.18	0.19	0.37	0.43
